10th CONFERENCE ON ASPHALT PAVEMENTS FOR SOUTHERN AFRICA

TOWARDS IMPROVED UNDERSTANDING OF SEAL PERFORMANCE

GD van Zyl, A van der Gryp

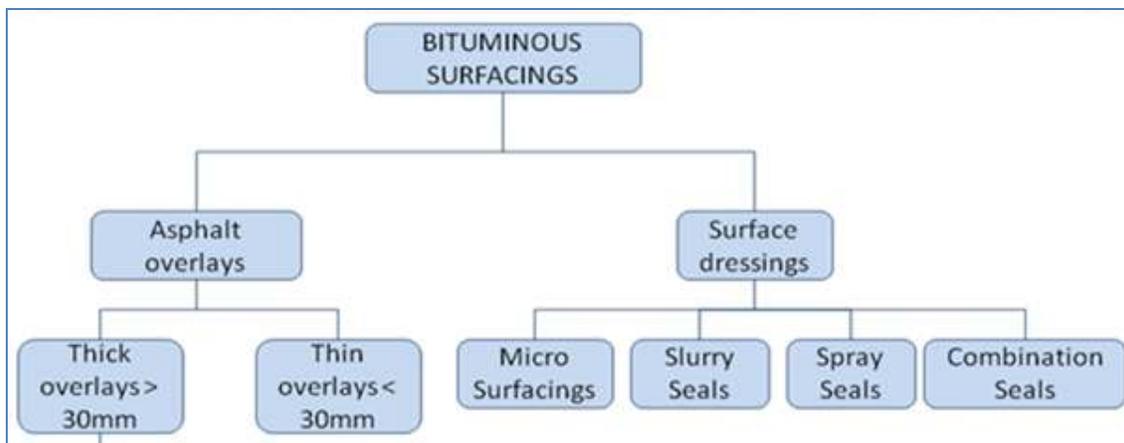
Bituminous surfacing types, for purposes of this paper, are divided into asphalt overlays and surface dressings as shown in Figure 1.

Figure 1 Bituminous surfacing types

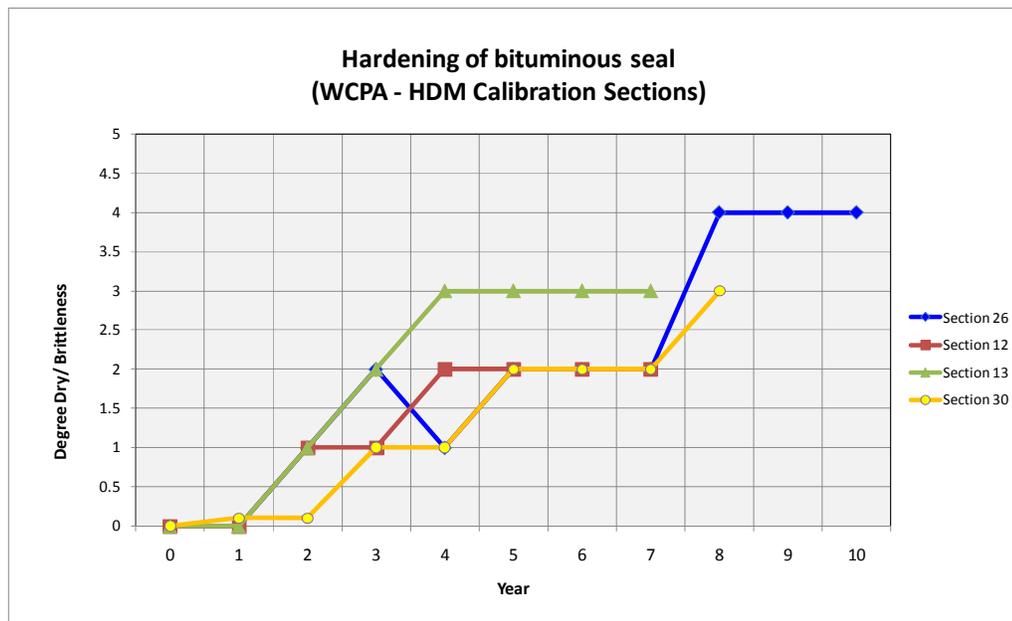
- Even though concerns have been raised regarding the subjective assessment of binder condition within a bituminous surfacing, evaluation of the data set indicated that the assessment of hardening/ oxidation of the binder show definite trends. The data as recorded for four sections are displayed in Figure 2.

Figure 2 Increase in Degree of “Dry/ Brittleness”

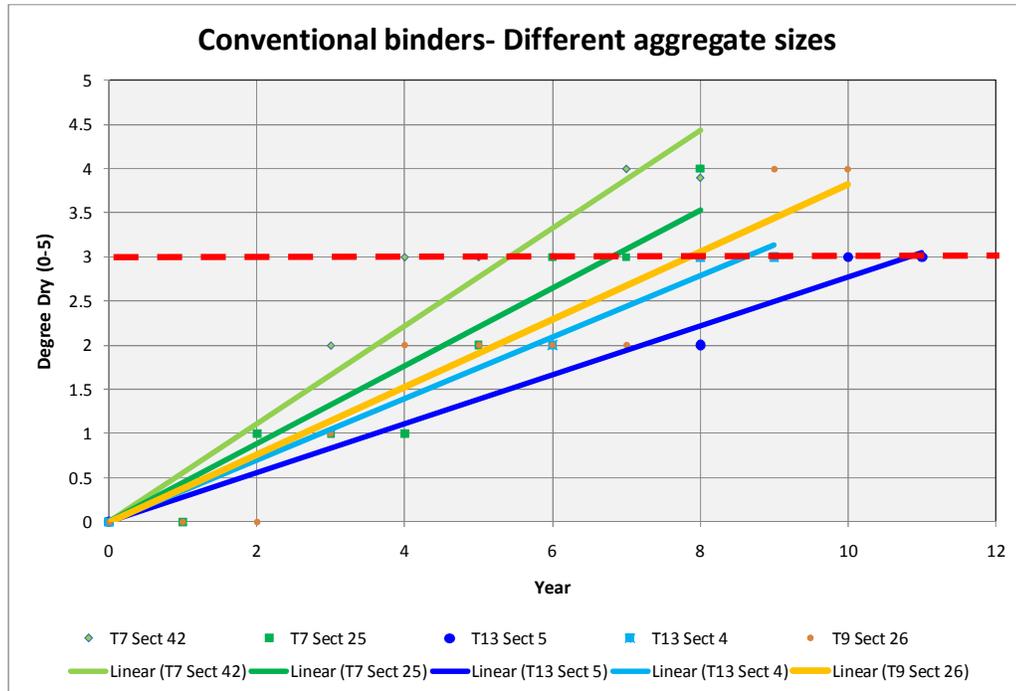
- The expected seal age before a dry/brittleness of degree 3 is recorded is, amongst other factors, dependent on the seal type (Aggregate size) as shown in Figure 3:

- T7 (6.7 mm single seal) with conventional binder = 5-7 years
- T9 (9.5 mm single seal) with conventional binder = approximately 8 years
- T13 (13.2 mm single seal) with conventional binder = 9-11 years

- Each linear trend line represents the average of 20 road segments
- The larger the aggregate size, the higher the binder application

Figure 3 Ageing as a function of aggregate size

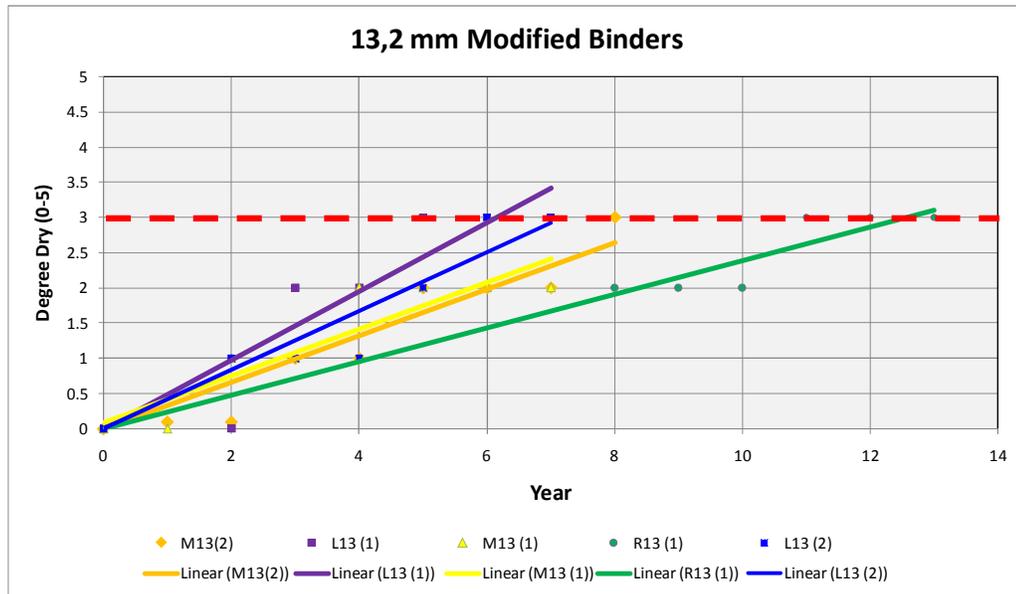
- There appears to be a definite difference in the ageing characteristics between different types of modified binder seals e.g. average time to Degree 3 dry/ brittleness being recorded:
 - L13 (13,2 mm with Homogeneous polymer modified cold binder) = 6-7 years
 - M13 (13,2 mm with Homogeneous polymer modified hot binder) = 8-9 years
 - R13 (13,2 mm with Non-Homogeneous polymer modified hot binder) = 11-12 years

Figure 4 Ageing of modified binder seals

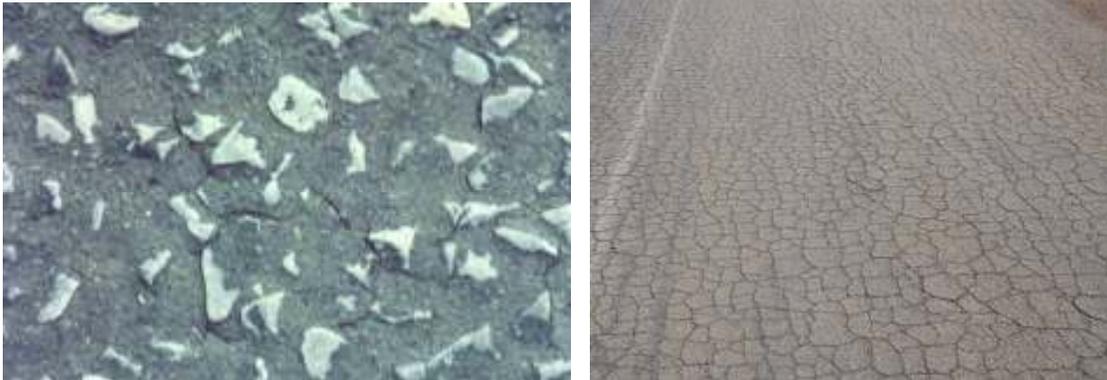
TMH9 describes surfacing cracking as cracking only occurring in the bituminous surfacing as a result of shrinkage of the binder. Although there are several arguments against the stated mechanism of crack forming, observations over more than thirty years have resulted in this defect being incorporated into the standard visual assessment methodology. The development and progression (TMH9) are as follows:

- Fine star pattern cracking firstly appear on the non/low-trafficked areas such as on the surfaced shoulders or in-between the wheel tracks or, in the case of very low volume roads, over the full surfaced area.
- Cracking then progresses into a typical crocodile skin pattern.

Photograph 1 Surfacing cracking

- Oxidation and hardening of the bituminous binder occur (Fact)
- Possible vertical moisture ingress through a more permeable seal, which could result in softening of any granular base
- The bituminous surfacing stiffens, with time, to such an extent that it becomes sensitive to even slight deflections
- Hardening of the binder in the wheel tracks is slower as a result of the kneading action of tyres. Therefore, first observed between wheel tracks.
- Fatigue of this stiff layer occurs, resulting in a typical fatigue crack pattern

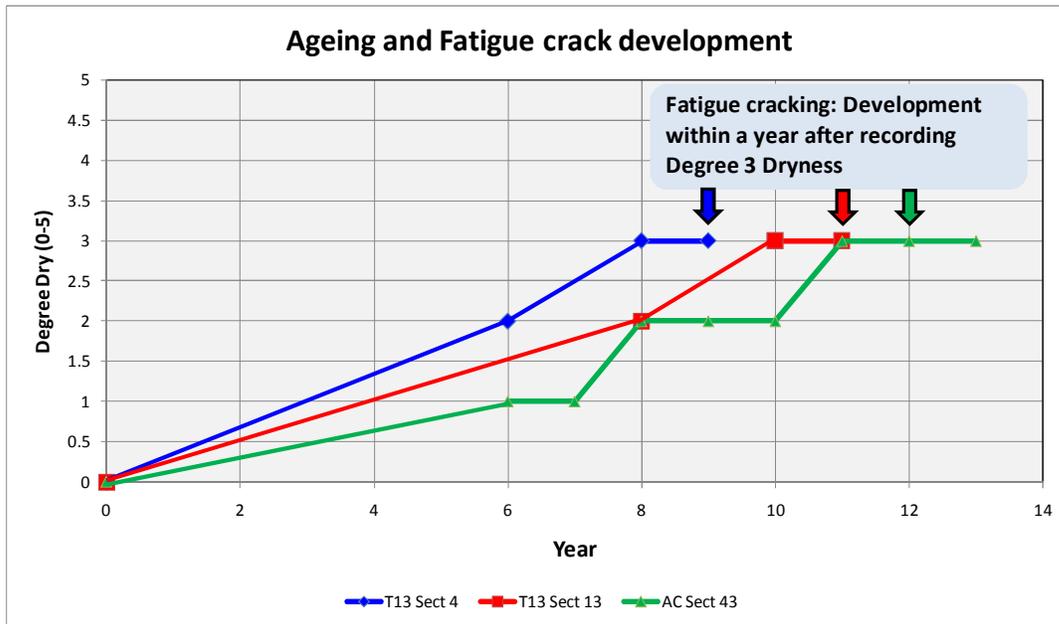
- Even on roads which are considered to be structurally sound and without rut deformation, crocodile pattern cracking is typically observed on the road surface soon after the binder condition is rated as a Degree 3 – Typically within a year. Figure 5 shows the hardening of the binder on three road sections and the first signs of fatigue/crocodile pattern cracking.

Figure 5 Fatigue crack development as a function of binder ageing

Even though the sample size is small, the trend results tie in with the experience of personnel of the Roads Branch, and to a large extent with performance models already incorporated into the WCPA Pavement Management System (Van der Gryp Henderson and Van Zyl, 2010).

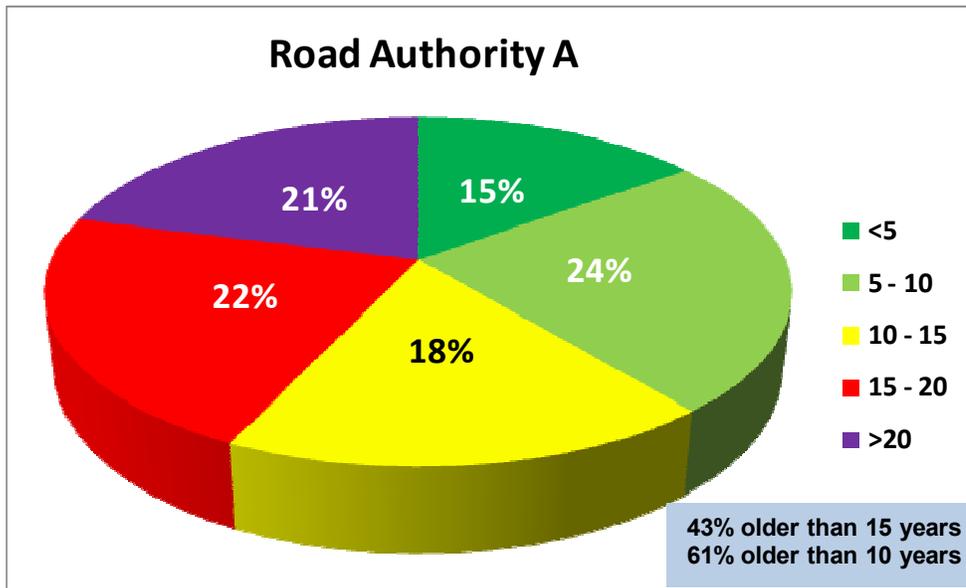
As shown in Figure 6, Figure 7 and Figure 8 the percentage of seal ages more than ten years on each surfaced road network is as follows:

- Road Authority A = 61%
- Road Authority B = 43%
- Road Authority C = 80%

Figure 6 Last seal age per category (Road Authority A)

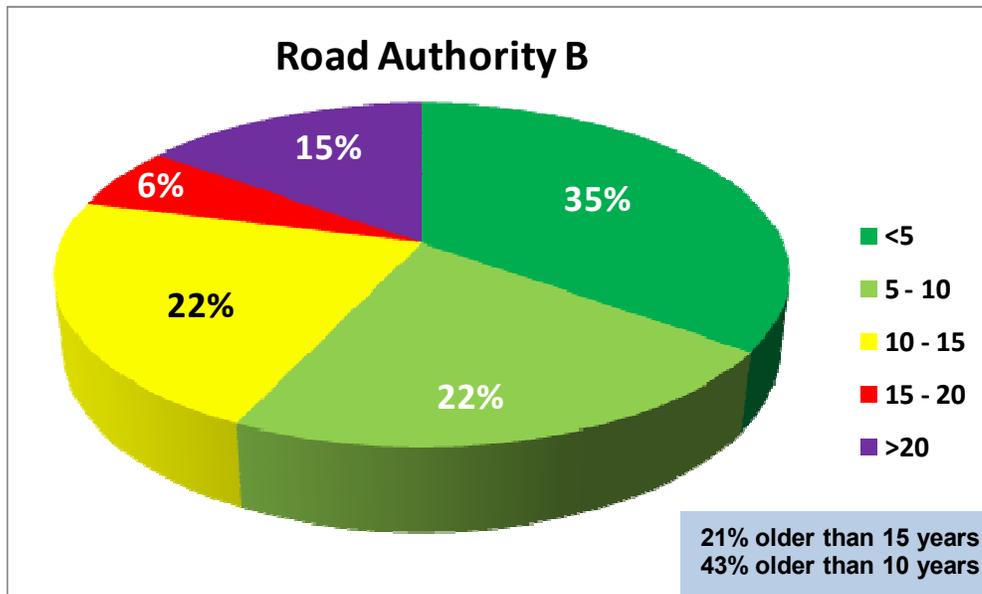
Figure 7 Last seal age per category (Road Authority B)

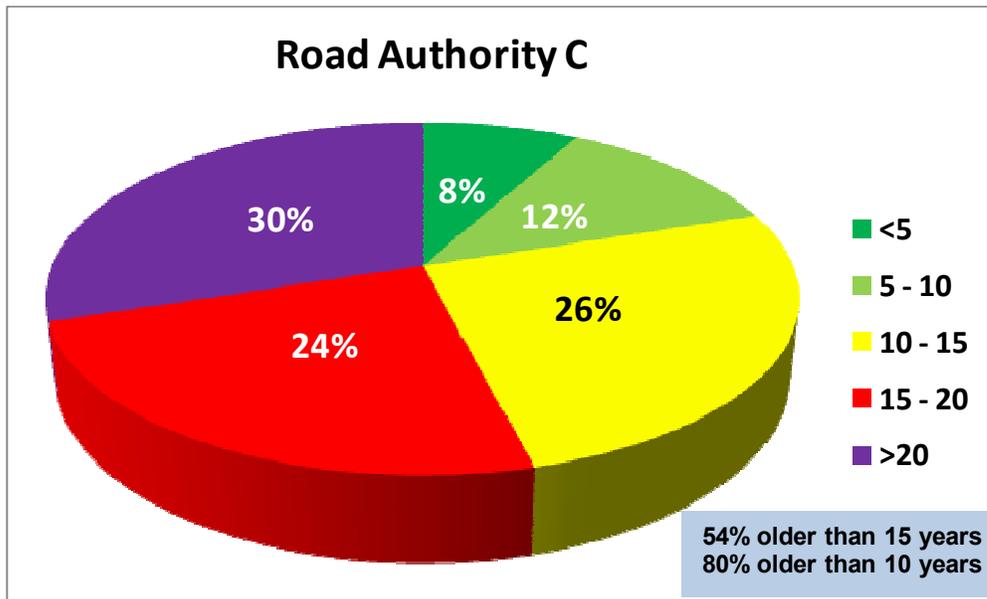
Figure 8 Last seal age per category (Road Authority C)

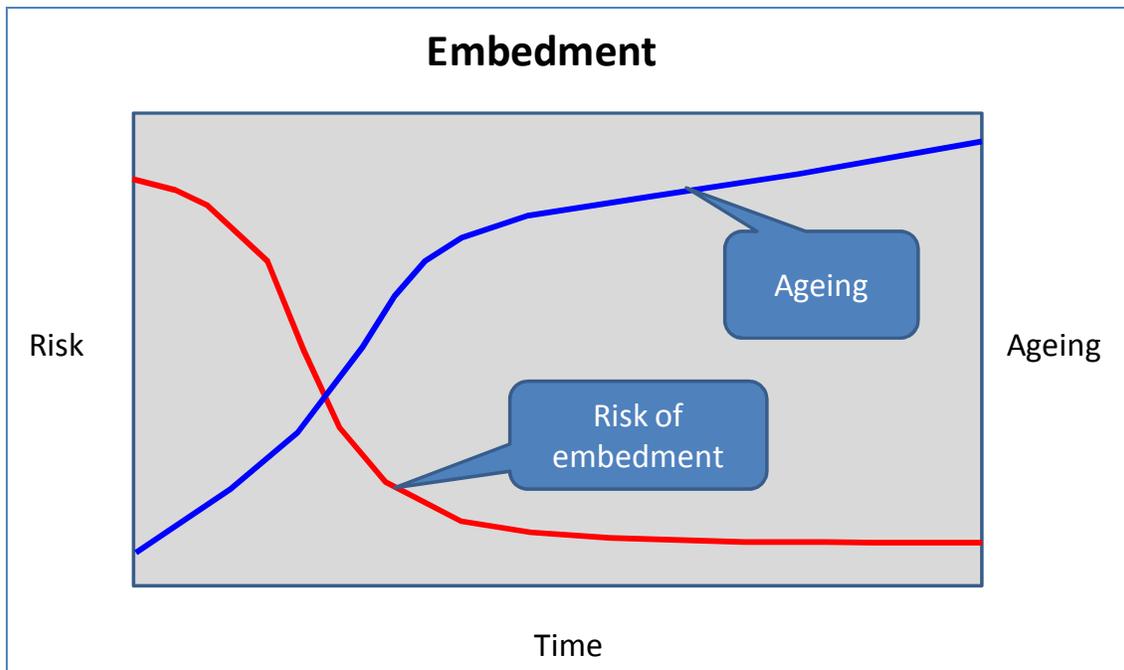
The risk of bleeding during the life of the surfacing due to embedment is explained in Figure 9.

Figure 9 Risk of embedment with time

The loss of voids in the aggregate matrix for design purposes is estimated from ball penetration testing (TMH6) and the expected traffic volume. A dramatic increase in heavy vehicle loads and tyre pressures has taken place since the related studies (Marais, 1979) and urgently requires update.

Embedment occurs as a result of the vertical force on individual stones within the seal matrix. The rate and degree of embedment is a function of the stiffness of the underlying layer, the load on individual stones, the stiffness of the binder and the friction between aggregate particles.

One of the positive effects of binder oxidation/ hardening is that the seal, with time starts to act as a layer to distribute the load. The effect on individual stones and the embedment potential, therefore, reduces as the binder hardens.

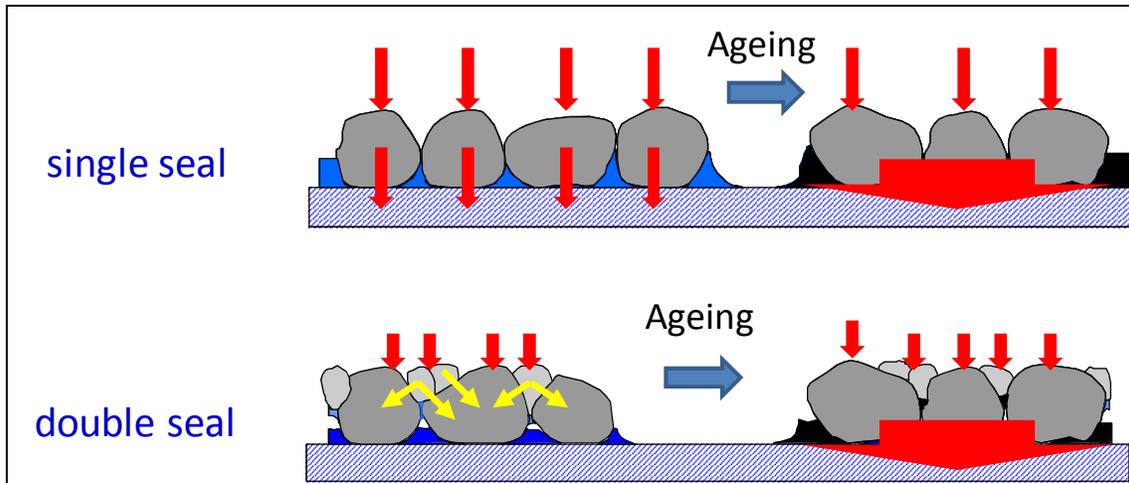
Figure 10 Effect of ageing on load distribution

The concept is explained in Figure 10. Initially the load on the single seal is directly transferred to the underlying layer. With ageing of the binder, the seal starts to act as a layer. The contribution to the structural capacity drastically reduces when fatigue of the layer results in cracking.

Taking into account the geometry of different seal types and the ageing of the binder, the hypothesis is that the seal, apart from reducing moisture ingress, could certainly contribute to the structural capacity of the pavement. The degree is determined by the degree of binder ageing and the friction between the aggregate particles.

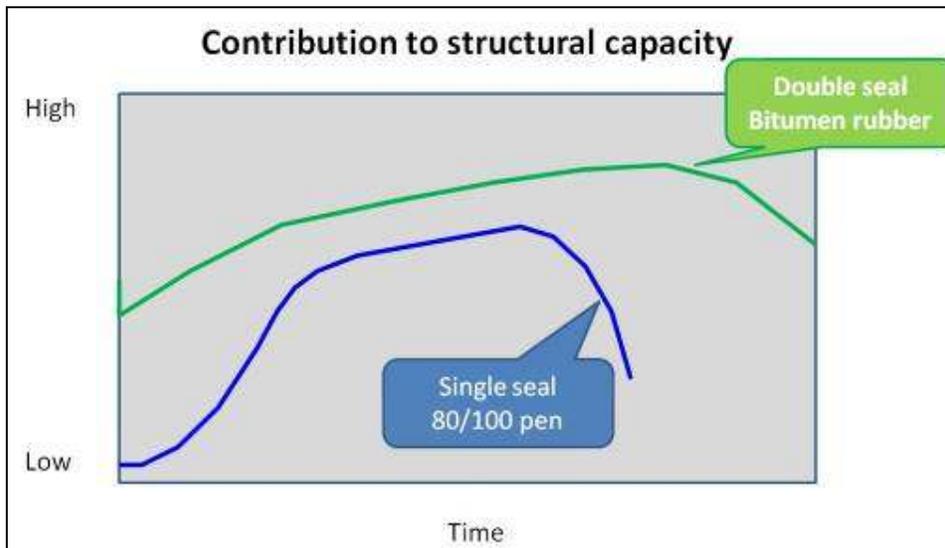
In the case of the double seal, the friction between aggregate particles already adds to the strength of the seal. The binder also ages with time, resulting in increase of the layer stiffness. In case of the bitumen rubber binder, the rate of ageing is much slower and time to fatigue much longer. Refer Figure 11.

Figure 11 Seal contribution to pavement structural capacity

Note: The concept will be evaluated by testing the stiffness and fatigue characteristics of different seal types at different ages

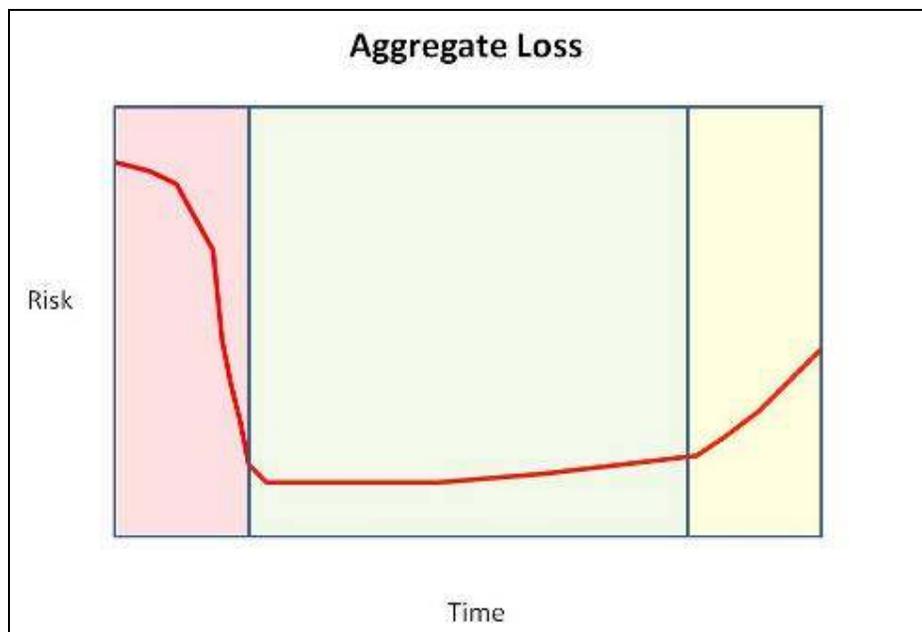
The risk of general aggregate loss, as shown in Figure 12 for spray seals, is at its highest just after construction and decreases with time with most aggregates found in southern Africa. Seal deterioration due to aggregate loss, as evaluated from the available data, is almost insignificant.

However, it is acknowledged that seals constructed with specific aggregates such as certain quartzites and granites, do show an increase in risk of aggregate loss with time, probably due to ageing of the binder and poor bond strength.

Figure 12 Risk of aggregate loss (Spray seals)

Loss of aggregate soon after construction mainly occurs as a result of low bond strength, aggravated by low temperatures and/or moisture (rain), influencing the adhesion and/or cohesion. Experience in South Africa indicates that, once the seal has "settled" (increase of surface contact area and binder cohesion development) the risk of aggregate loss is generally low. Situations vary, but severe aggregate loss (stripping) seldom occurs after the first winter.
