## **APPLICATION OF INNOVATIONS AND LESSONS LEARNT ON A SINKHOLE PRONE RUNWAY RECONSTRUCTION**

Bruce Morton<sup>1</sup> , Emile Horak<sup>2</sup> and Gert van Niekerk<sup>3</sup> Elsabe van Aswegen<sup>4</sup>

### **SYNOPSIS**

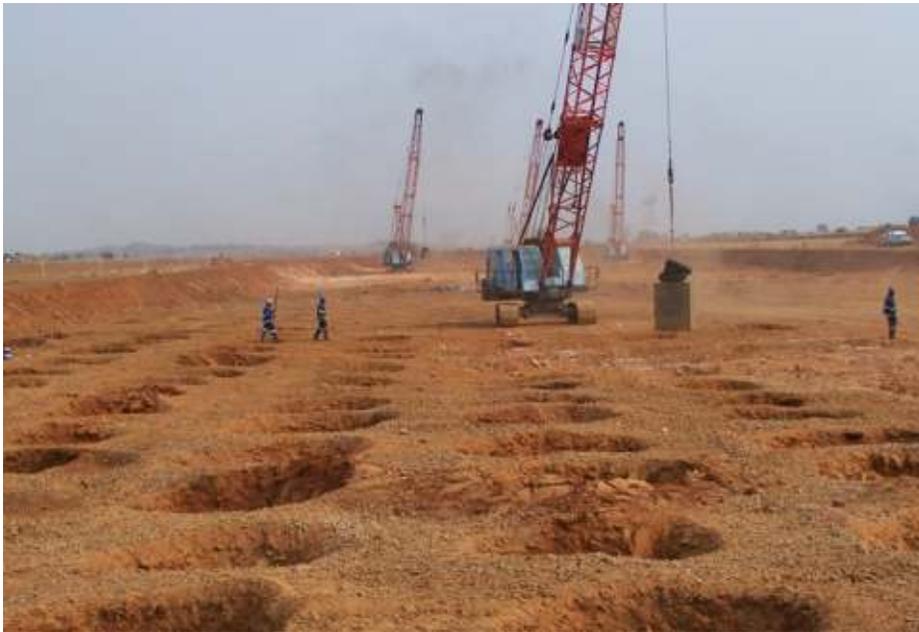
Figure 4: Dynamic Compaction in progress

DC was achieved by applying weight drops of 12 tonnes through an 18 m drop height. The process comprised of primary compaction applied in a grid pattern of 5 m x 5 m, followed by secondary compaction applied in the same grid pattern but at an offset from the primary grid, completed by finishing or ironing. Primary and secondary compaction weights were rectangular (1.2 m<sup>2</sup> in area) while the ironing weights had a larger diameter (2.5 m<sup>2</sup>). Ironing compaction was applied with 50% overlap of each weight drop. At the height of construction 15 cranes were utilised on WAFB to undertake the DC.

At Threshold 19 (northern threshold) the DC comprised of a single pass of 15 blows each for primary and secondary compaction, with some isolated areas requiring an additional 5 blows, and ironing for the first 500m. DC at Threshold 01 (southern threshold) was more extensive, resulting in up to four passes of primary DC before continuing with secondary DC. The coarse aggregate of the Waterbound Macadam was found to be suitable as stone column filling material in the settlement holes, thereby recycling the material. The same principle was followed for secondary compaction, requiring up to three passes of DC. Both threshold areas were filled with a G6 quality material after DC and compacted with IC and normal roller compaction to at least 93% Mod AASHTO density. For areas requiring subgrade structural improvement rockfill was created through the recycling of approximately 1200m<sup>3</sup> of old concrete slabs demolished from the thresholds.

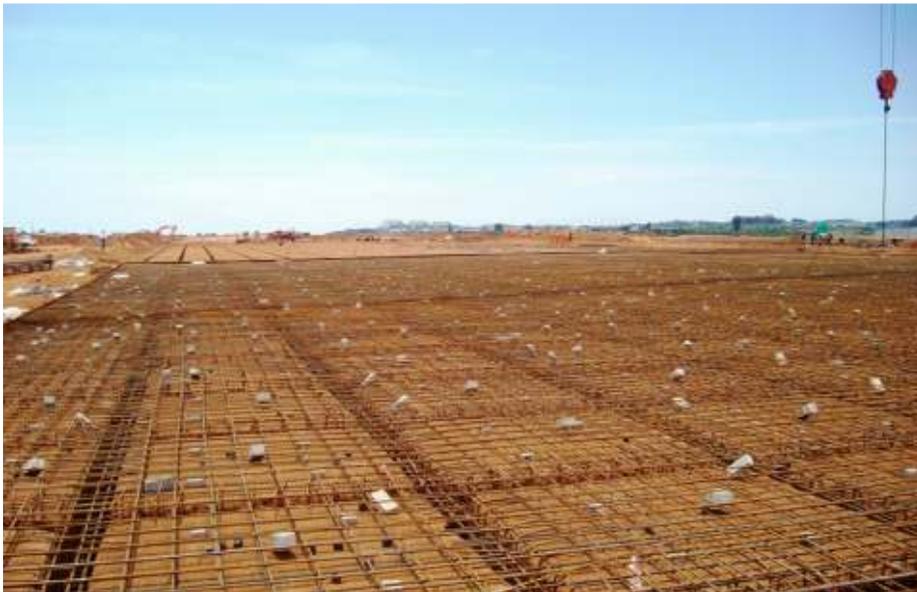
**Figure 5: Concrete raft foundation reinforcement**

concrete rafts were designed to improve risk management. The ribs were designed to be 250 mm wide x 1m deep and the waffle core was 2.5m x 2.5m and a 200 mm slab. The rafts were constructed in 55m x 55m large monolithic continuous slabs. These represent the largest in-situ raft foundations constructed in a single pour operation within southern Africa. A total of 8 and 9 rafts were cast under the northern and southern landing zones, respectively.

The existing pavement selected layers were recycled through crushing and screening to produce a -19 mm G6 material for construction of a 1 m thick lower selected layer subbase. Thereafter the rib space was excavated with a ditch-witch to a 50mm tolerance. During the height of the rainy season the 2.5m X 2.5m inner G6 islets were protected with plastic covers. The fixing of the steel proved to be a logistical challenge, complicated by the in-situ soil formwork. Once the steel had been fixed the pouring of the 55 m x 55 m slabs was undertaken over a 12 hour shift with increasing speed and efficiency of the complex operation. Following the initial curing accomplished through a combination of continuous wetting and application of curing compounds, the completed raft slabs were covered with a loose layer of the G6 material previously removed from rib channel excavation operation to undergo further curing.
