## CRACKING AND STAINING OF AN AIRPORT ASPHALT

F Netterberg <sup>1</sup>, AW Hefer <sup>2</sup>, H Du Preez <sup>3</sup>

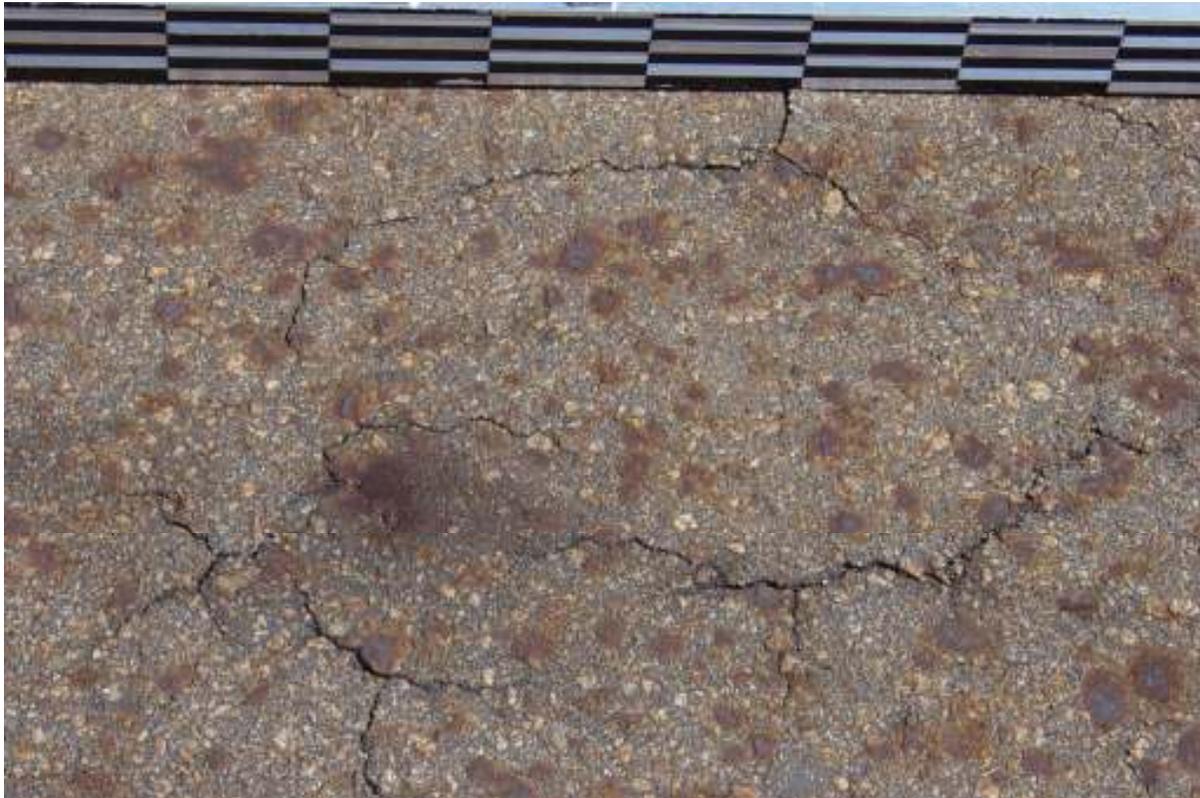
The cracking in question was seen to be of a random, tending towards hexagonal pattern where best developed, averaging about 3 - 5 mm in width and on a spacing of 100 - 500 mm, averaging about 300 mm (Figure 1), and extended over most of the asphalt.

The staining consisted of brown spots mostly 10 - 20 mm in diameter comprising a dark, reddish brown core surrounded by a lighter, reddish brown halo and occurred on a random pattern, with a spacing of 20 - 100 mm. They appeared to emanate from the coarse aggregate, and extended over most of the asphalt surface. In places, a small proportion of the exposed course aggregate itself was brown and weathered in appearance and in a few cases had weathered out completely, leaving a pocket.

**Figure 1. Typical Cracking and Staining (scale in 100 mm intervals)**
