**NOVEL MEASURES TO ATTENUATE AGGRESSIVE SALT MIGRATION AND CRYSTALLIZATION
ON A NAMIBIAN AIRPORT RUNWAY PROJECT**

E Horak¹, S Emery² and H Walker³

Abstract

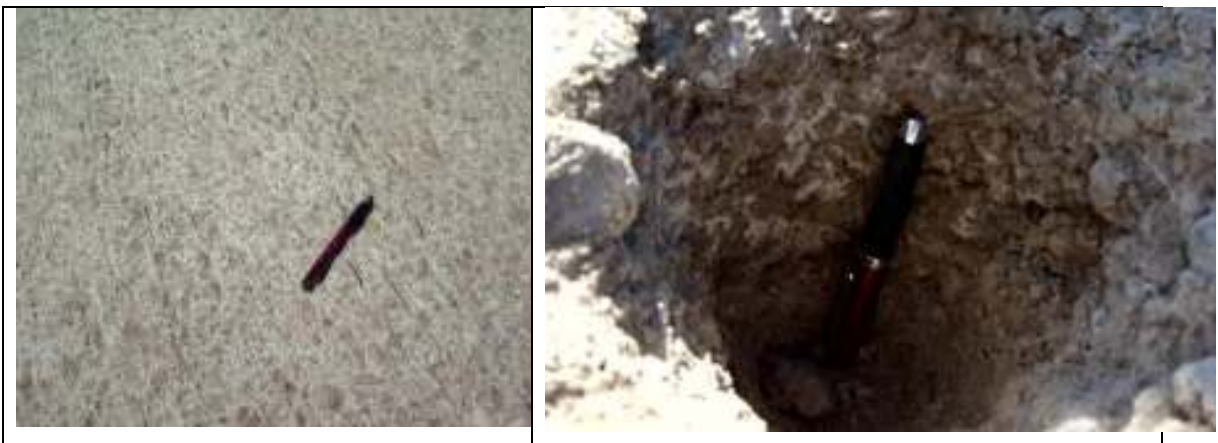
Figure 1. Salt dust on trial section of G1 base surface and density hole soon after construction.

When the constructed base layer also exhibited very rapid salt crystallization, even though the parent rock was salt free, the alarm bells rang loud and clear. In Figure 1 crystallization can be observed on top of the base course and inside a density test hole.

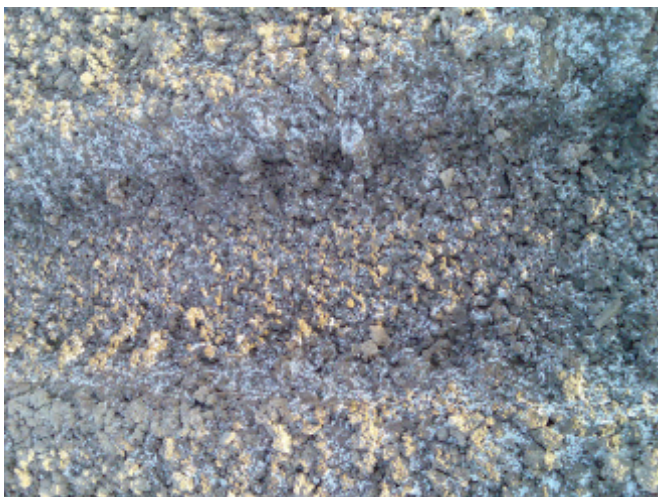
Figure 2. Aerated G1 emulsion mix showing evidence of salt crystallization appearing overnight.

The bitumen emulsion in small concentrations was found to act successfully as a compaction aid by reducing the water required and thus it reduced the risk of immediate salt formation. The value of the emulsion addition was also that the white salt crystallization was clearly contrasted in colour in the darkened granular mix. In Figure 2 the salt crystallization is clearly observed in the treated and overnight aerated emulsion mix prior to compaction.
