COST EFFECTIVE METHOD FOR WIDENING OF BITUMINOUS SURFACINGS USING A COARSE GRADED SLURRY

This paper reports on the various aspects of the edge widening process which has been conducted on a 175 km section of Namibia's Trunk Road 1 between Rehoboth and Mariental. The subsequent methodology of the construction process and the cost effectiveness of this remedial action is evaluated and reported on.

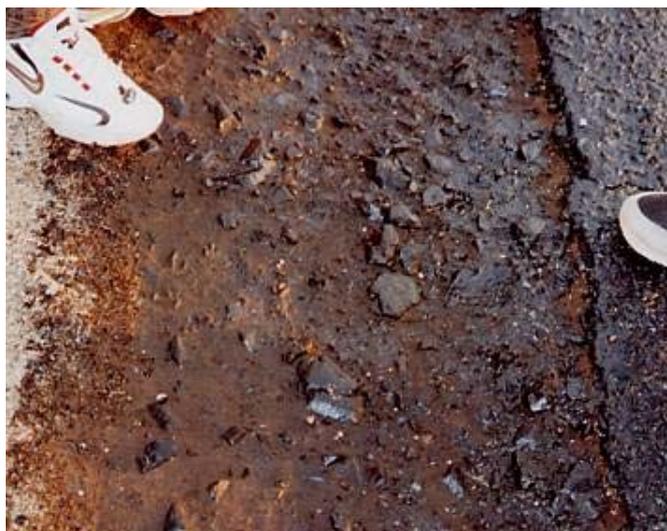
Picture 1. Primed shoulder.

- The shoulder was first treated with weed killer before the existing vegetation was later removed by hand.
- The existing shoulder was then swept by hand to remove any loose material. This material was reused in later re-shouldering.
- Inverted bitumen emulsion prime was then sprayed at an application rate of 0.9 litres per square metre on the swept shoulder and left open to cure.

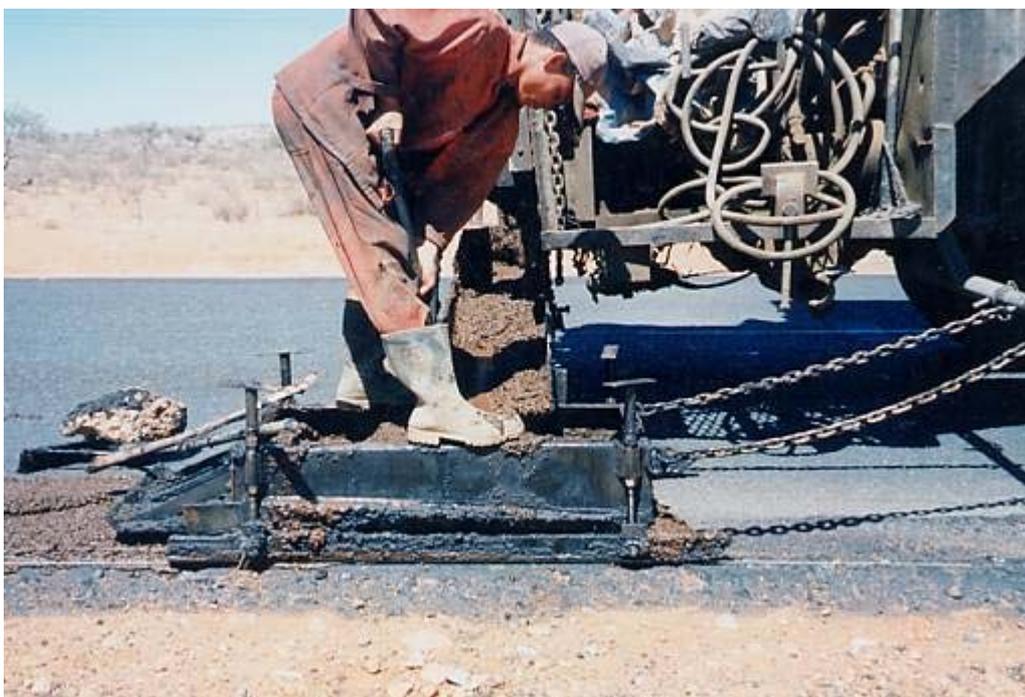
Picture 2. Placing coarse graded slurry.

A string line was erected on the shoulder to demarcate the outside edge. The coarse graded slurry was mixed in a continuous mixing machine and poured into a purposely-designed box for placing in a single pass. Initially the slurry was poured via a chute and spread by hand between the road edge and steel shuttering. Once confidence had been built up in the performance of the slurry mixture, a spreader box was used to place the slurry negating the need for using shuttering. The box was designed so that it was dragged from an arm behind the machine. The bulk of the box ran on the existing surface while the outside edge operated on a spring-loaded skid. A strike off plate would ensure that the freshly placed slurry would be leveled off with the existing road surface. The average depth that the slurry was placed was 35 mm with the maximum reaching 50 mm at times. The fresh slurry edge widening was rolled with a pneumatic tyred roller 3 hours after placement prior to opening to traffic.

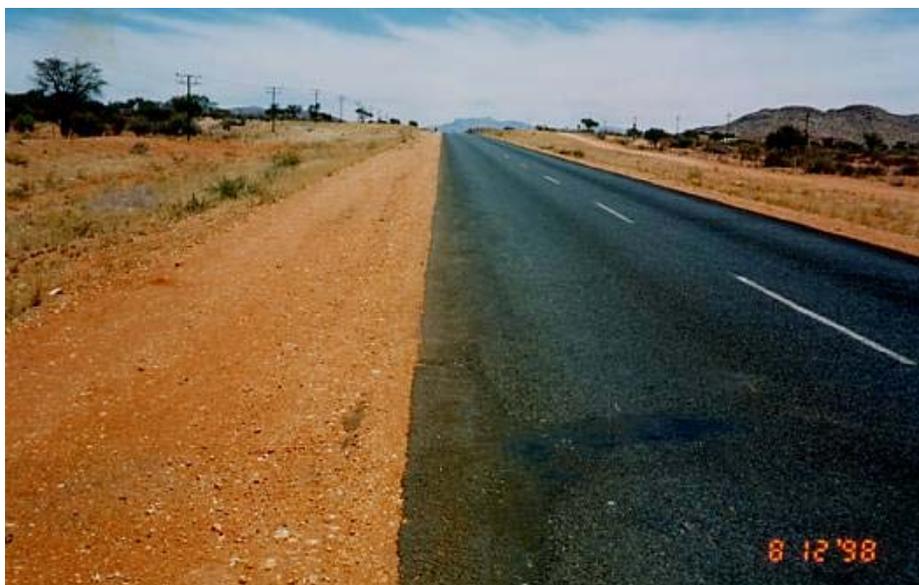
Picture 3. Finished edge widening.
